FlashSeal™

ELASTOMERIC FLASHING SEALANT

Long-Lasting Flashing Repair

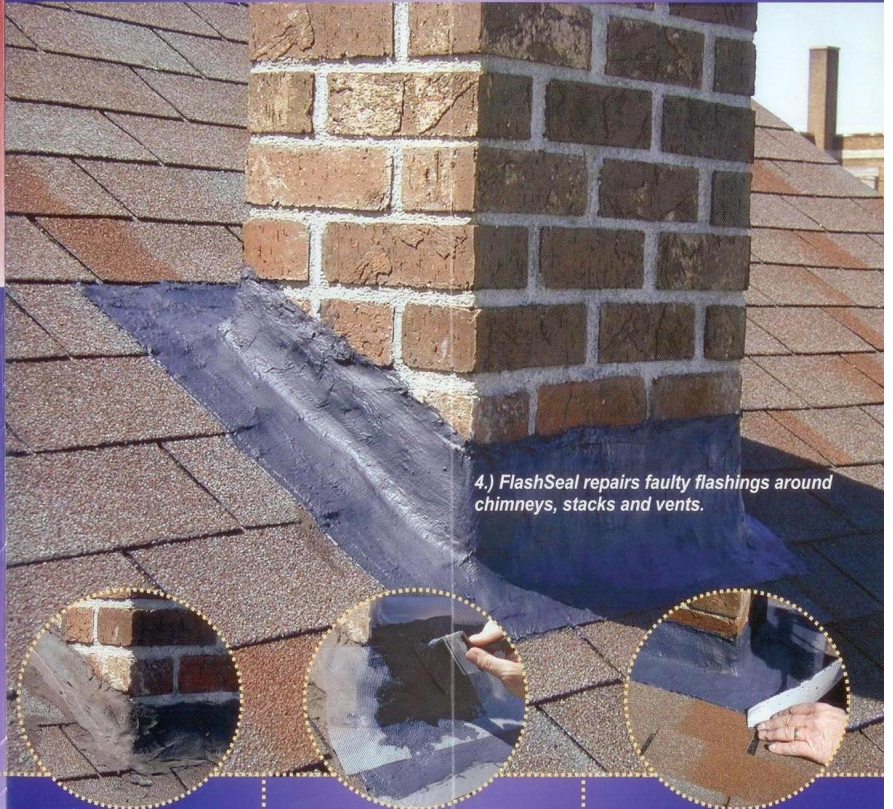
4.) FlashSeal repairs faulty flashings around chimneys, stacks and vents.

1.) Chimney with cracked and deteriorated flashing.

2.) For added strength and flexibility a fiberglass fabric is embedded between 2 coats of FlashSeal Elastomeric Sealant

3.) In most cases the roof deck and chimney are taped off to produce a neat appearance of the finished application.

A professionally installed FlashSeal application is like installing a custom fit waterproof boot at the base of your chimney.
